DA/101/2019 - Hornsby Quarry - Landform Modification

While we accept the development of the Hornsby Quarry for parklands, we object to the following issues regarding this current landform modification development application by Hornsby Council:

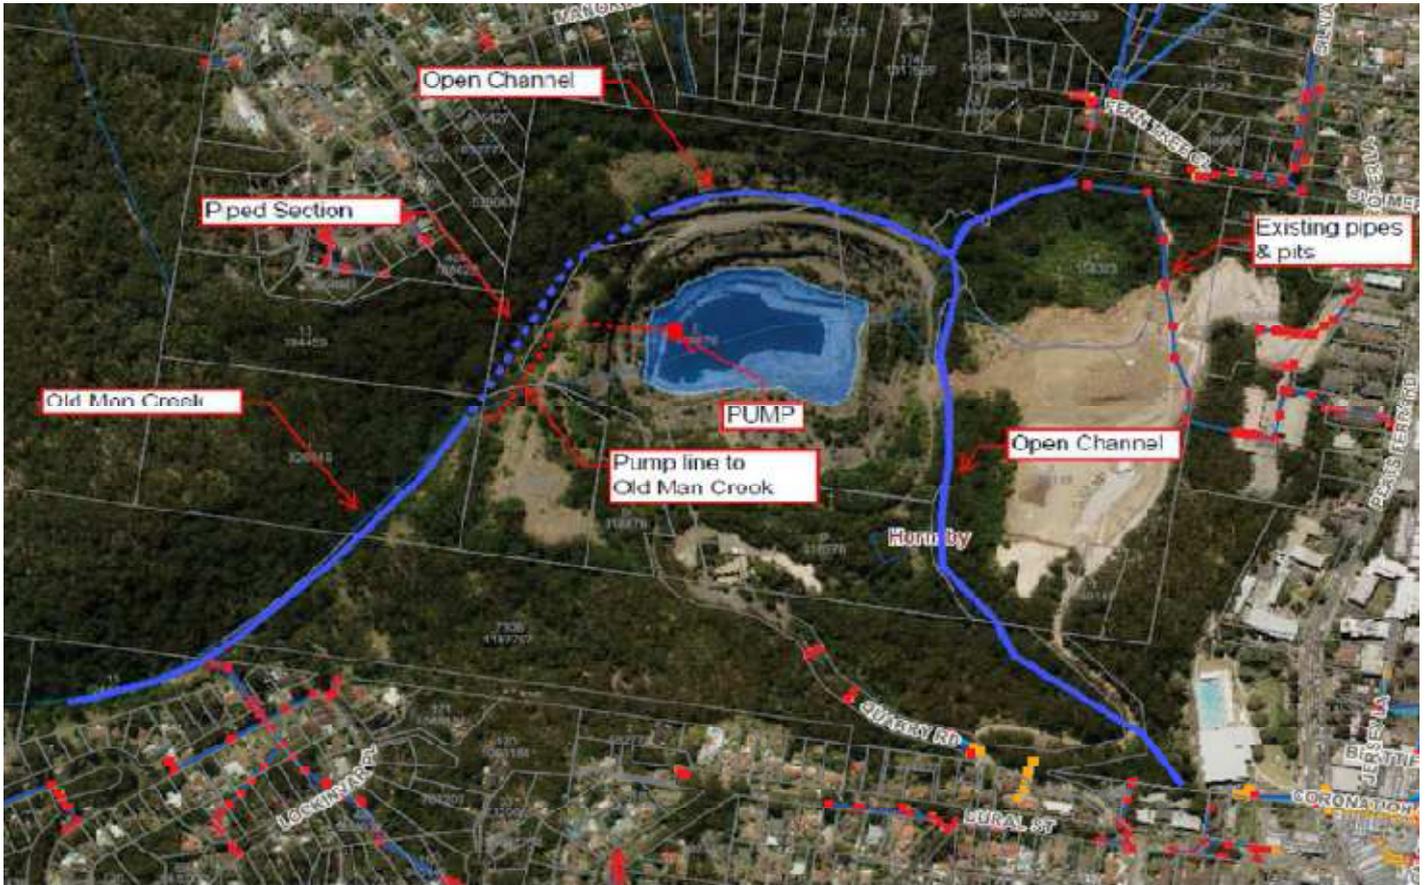
Diagram #2 - Stormwater line shown through south-western lot

HORNSBY PARK STORMWATER DRAINAGE LAYOUT

It is therefore considered that the Extent of Works as shown in Diagram #1 should be reduced to exclude Lot 1 DP734459 and Lot 1 DP926449 with the exception of the stormwater drainage line (Diagram #2), and that only future landscaping works be undertaken to revegetate this area. Indeed, this is one of the best areas on the Quarry site for Green Offset planting to occur, to offset any necessary tree removal on other portions of the site. As can be seen in Diagram #3, both the riparian zone around Old Mans Creek and nearby Forest would benefit from revegetation.

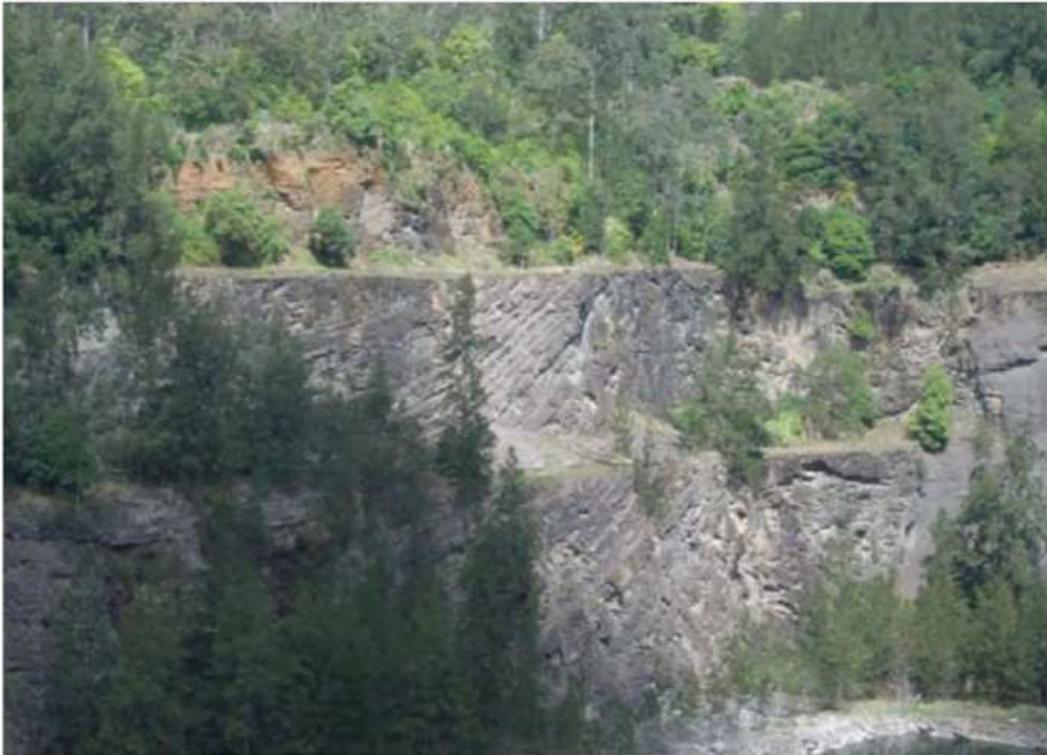
Photo #2 - Exposed Diatreme prior to filling of the Quarry - courtesy of Cardno report

Figure 5-7 Photograph of the Diatreme Area Located on the Eastern Face of the Quarry Wall.

This statement appears to suggest to the community that the exposed Diatreme will be preserved and that people will be able to see the Diatreme and understand its "significant values". However it can be seen from comparison of the before and after filling of the Quarry (Photos #2 & #3) that the exposed Diatreme has been all but buried. Photo #3 shows only a small portion still exposed and it is unknown how little of the Diatreme is visible at this time.
